# Manhole Inspection Summary

Manhole # S31CC\_010MH

**Location** Address: **EUTAW ST**

Cross Street: **PRESTON ST**

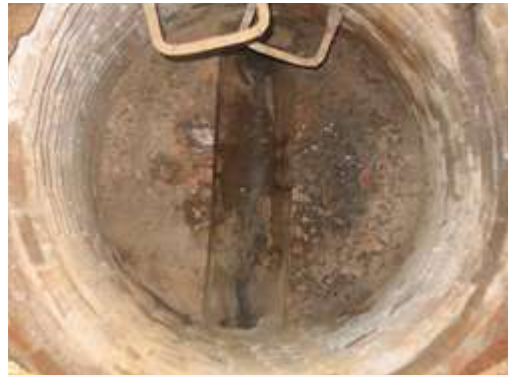
Top View

Corroded steps. Bench debris.

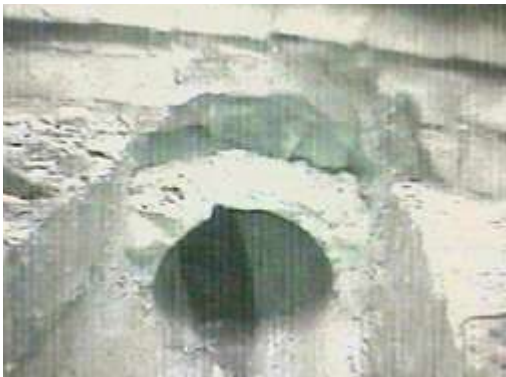
Defect

Barrel deterioration and infiltration.

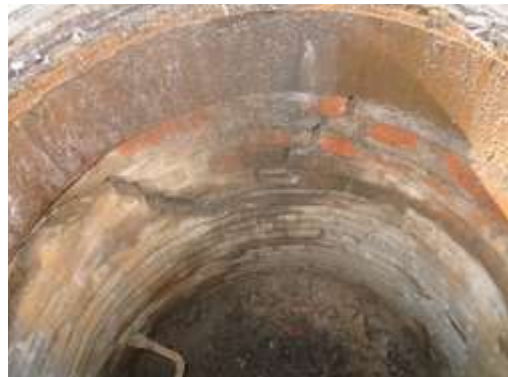
Defect

Frame leaks. Adjustment and Corbel deterioration, cracks and infiltration. Barrel infiltration.

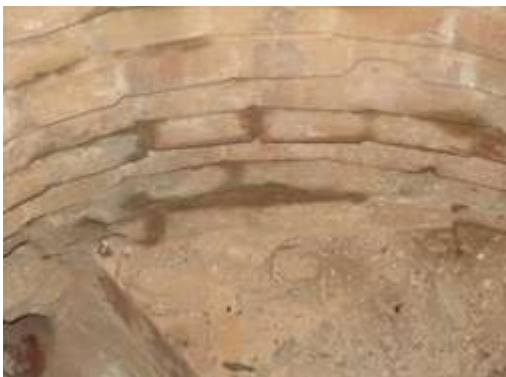
Defect

Barrel infiltration.

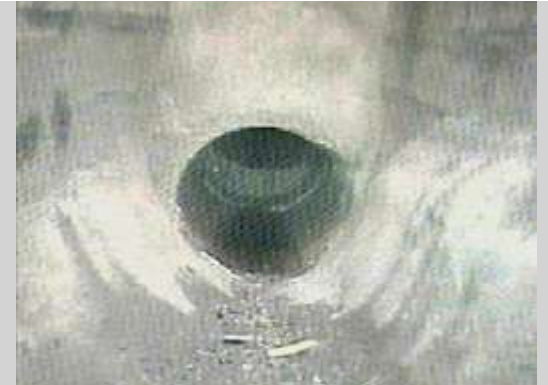
### 8 in. Circular Gravity Sewer Pipe Out @ 12 O'Clock

Deposits: ☐ None ☒ **Mud** ☐ Sludge ☒ **Debris** ☐ Grease

Silt Depth: **0** (in.) Deposits Extent: **Light**

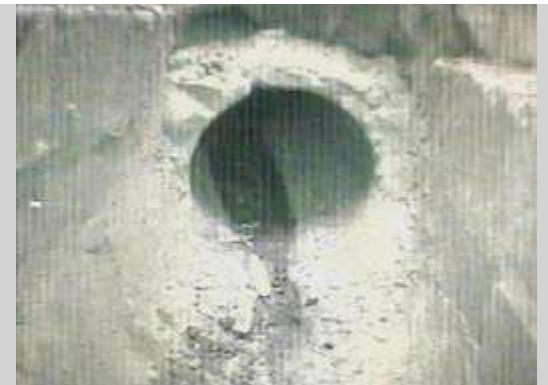
### 8 in. Circular Gravity Sewer Pipe In @ 6 O'Clock

Deposits: ☐ None ☒ **Mud** ☐ Sludge ☐ Debris ☒ **Grease**

Silt Depth: **0** (in.) Deposits Extent: **Light**
